**Flood Control Project Maintenance
Levee Inspections**

Maintenance Issue Types Only, Levee Inspection Report By Mile - Fall 2018

Eastern Honcut Creek

Waterway	Bank	Unit Miles	Inspection Start/End	Inspector
Unit No. 01 Van Tress	Left	1.46	09/18/2018 09/18/2018	Sterling York

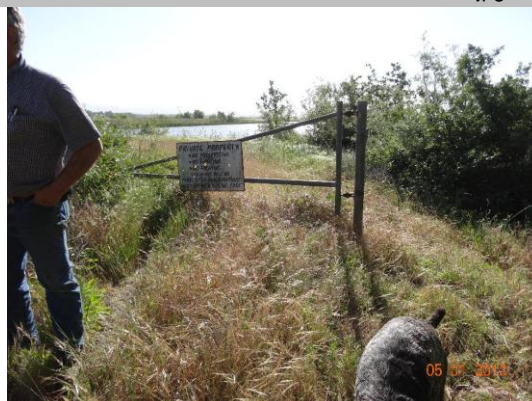
Photo 1 of 3 : UCIP_FA_2018_52800_24228.jpg

LM Start	0.01	Rating **	M	Issue No.	26	
LM End	0.01	Issue Type +	Ma	Location *		
Category	Supplemental			GPS Latitude/Longitude		
				Start	End	
Item	DWR UCIP LMA Responsibility			39.298484 °	39.298484 °	
				-121.569610 °	-121.569610 °	
DWR ID	19167					
Comment Code						
Inspector Comment						
FS_ID:52800						
DS_ID:19167						
EP_NO: N/A						
Repair Type: Non-Urgent						
Crossing Status: Found						
UCIP Comments: 05/01/2013 Dense vegetation on landward side obstructs inspection. Vegetation needs to be cleared to perform utility crossing inspection. (DWR UCIP - O. Magana)						
FIELD_STRUCT_DESC: 24-inch corrugated metal drainage pipe through the levee, 12 feet below the crown. Flap gate located on the waterside (WS) end. [Additional Reference(s): DWR Levee Logs, 2005. USACE Sacramento O&M Manual Unit No. 151, November 1953, (Station 0+60)]						
FS Date: 5/1/2013

View of crown looking east.

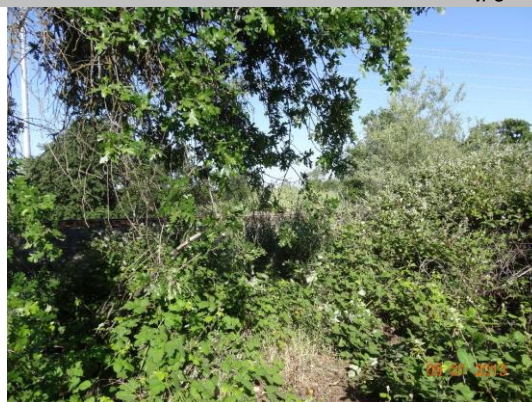
Photo 2 of 3 : UCIP_FA_2018_52800_24225.jpg

View of railroad looking west of crossing.

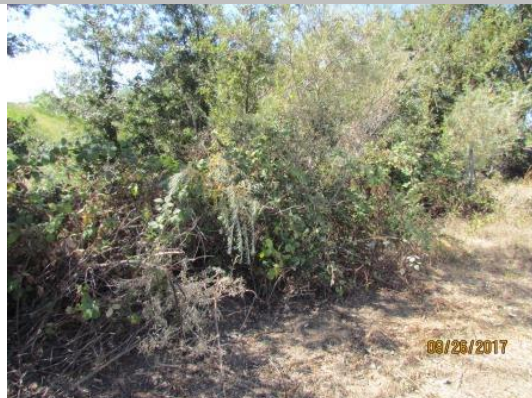
Photo 1 of 1 : FA_2018_NA0006_252_8_20180918_00002.jpg

LM Start	0.02	Rating **	U	Issue No.	8
LM End	0.06	Issue Type +	Ma	Location *	LS
Category	Earthen Levee			GPS Latitude/Longitude	
				Start	End
Item	Vegetation			39.298486 °	39.299052 °
				-121.569504 °	-121.569277 °
DWR ID	DWR_NA0006_01_s_2017_8				
Comment Code					
V2 : Remove the wild growth other than native grasses from the levee slopes.					
Inspector Comment					
Broad leaf thistle and bushes covering landside slope, Fall 2018.

View looking downstream of broad leaf thistle & bushes covering landside slope, Fall 2017.

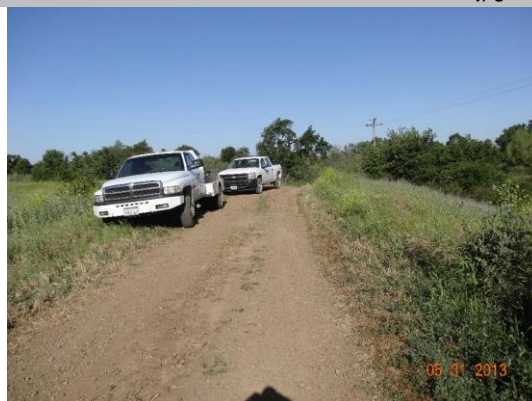
Photo 1 of 3 : UCIP_FA_2018_52801_24241.jpg

LM Start	0.09	Rating **	M	Issue No.	27
LM End	0.09	Issue Type +	Ma	Location *	
Category	Supplemental			GPS Latitude/Longitude	
				Start	End
Item	DWR UCIP LMA Responsibility			39.299106 °	39.299106 °
				-121.568749 °	-121.568749 °
DWR ID	19168				
Comment Code					
Inspector Comment					
FS_ID:52801 DS_ID:19168 EP_NO: N/A Repair Type: Non-Urgent Crossing Status: Found UCIP Comments: 05/01/2013 Dense vegetation on waterward side and landward side obstructs inspection. Need to clear vegetation on slopes to conduct proper crossing evaluation. (DWR UCIP - O. Magana) FIELD_STRUCT_DESC: 24-inch corrugated metal drainage pipe through the levee, 10 feet below the crown. Flap gate located on the waterside (WS) end. [Additional Reference(s): DWR Levee Logs, 2005. USACE Sacramento O&M Manual Unit No. 151, November 1953, (Station 5+65)] FS Date: 5/1/2013

Overview of levee crown at crossing looking upstream.

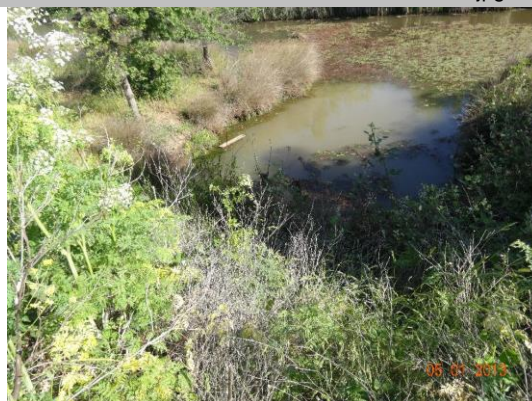
Photo 3 of 3 : UCIP_FA_2018_52801_24238.jpg

LM Start	0.09	Rating **	M	Issue No.	27 (cont)	
LM End	0.09	Issue Type +	Ma	Location *		
Category	Supplemental			GPS Latitude/Longitude		
				Start		End
Item	DWR UCIP LMA Responsibility			39.299106 °		39.299106 °
				-121.568749 °		-121.568749 °
DWR ID	19168					
Comment Code						
Inspector Comment						
FS_ID:52801 DS_ID:19168 EP_NO: N/A Repair Type: Non-Urgent Crossing Status: Found UCIP Comments: 05/01/2013 Dense vegetation on waterward side and landward side obstructs inspection. Need to clear vegetation on slopes to conduct proper crossing evaluation. (DWR UCIP - O. Magana) FIELD_STRUCT_DESC: 24-inch corrugated metal drainage pipe through the levee, 10 feet below the crown. Flap gate located on the waterside (WS) end. [Additional Reference(s): DWR Levee Logs, 2005. USACE Sacramento O&M Manual Unit No. 151, November 1953, (Station 5+65)] FS Date: 5/1/2013

Overview of waterward side (outlet).

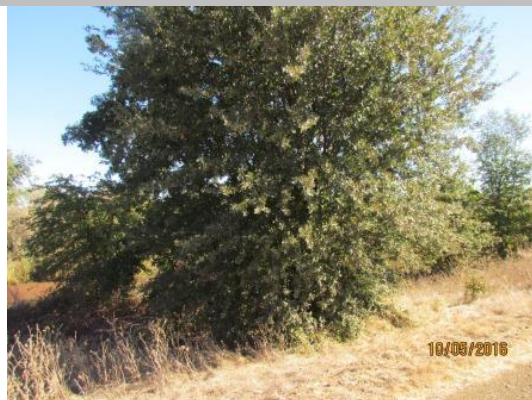
Photo 1 of 1 : FA_2018_NA0006_252_22_20180918_00008.jpg

LM Start	0.10	Rating **	M	Issue No.	22
LM End	0.10	Issue Type +	Ma	Location *	WS
Category	Earthen Levee			GPS Latitude/Longitude	
				Start	End
Item	Trim / Thin Trees			39.299078 °	39.299078 °
				-121.568633 °	-121.568633 °
DWR ID	DWR_NA0006_01_f_2016_22				
Comment Code					
T1 : Trim trees to at least five feet above ground level.					
Inspector Comment					
A tree that needs the limbs trimmed up 5' for visibility and access on the waterside. Fall 2018.

View of a tree that needs the limbs trimmed up 5' for visibility and access on the waterside. Fall 2016.

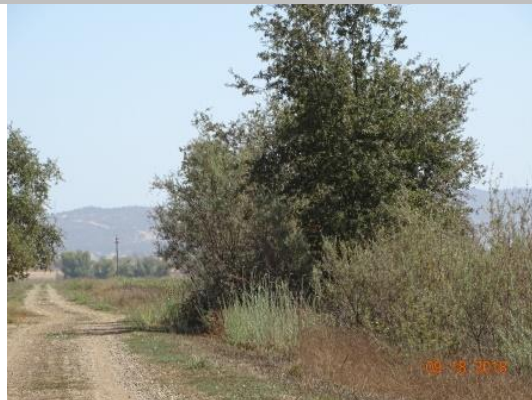
Photo 1 of 1 : FA_2018_NA0006_252_23_20181003_00027.jpg

LM Start	0.21	Rating **	U	Issue No.	23
LM End	0.21	Issue Type +	Ma	Location *	LS
Category	Earthen Levee			GPS Latitude/Longitude	
				Start	End
Item	Trim / Thin Trees			39.298816 °	39.298816 °
				-121.566529 °	-121.566529 °
DWR ID	DWR_NA0006_01_f_2016_23				
Comment Code					
T3 : Trim and thin trees to allow visibility of the ground and room to flood fight.					
Inspector Comment					
Trees that needs the limbs trimmed up 5' for visibility and access on the landside. Fall 2018.

View looking upstream landside of trees that needs the limbs trimmed up 5' for visibility and access on the landside, Fall 2018.

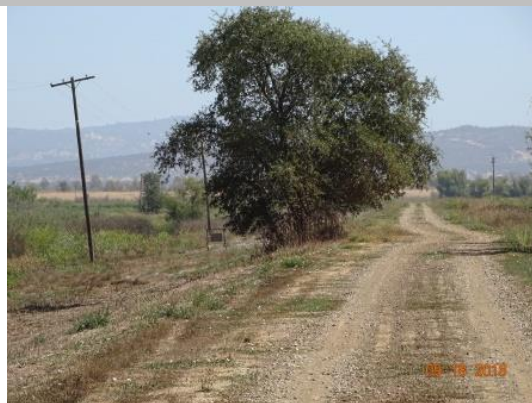
Photo 1 of 1 : FA_2018_NA0006_252_25_20181003_00028.jpg

LM Start	0.23	Rating **	M	Issue No.	25
LM End	0.23	Issue Type +	Ma	Location *	WS
Category	Earthen Levee			GPS Latitude/Longitude	
				Start	End
Item	Trim / Thin Trees			39.298776 °	39.298776 °
				-121.566158 °	-121.566158 °
DWR ID	DWR_NA0006_01_f_2016_25				
Comment Code					
T1 : Trim trees to at least five feet above ground level.					
Inspector Comment					
Tree that needs the limbs trimmed up 5' for visibility and access on the waterside. Fall 2018.

View looking upstream waterside of a tree that needs the limbs trimmed up 5' for visibility and access on the waterside, Fall 2018.

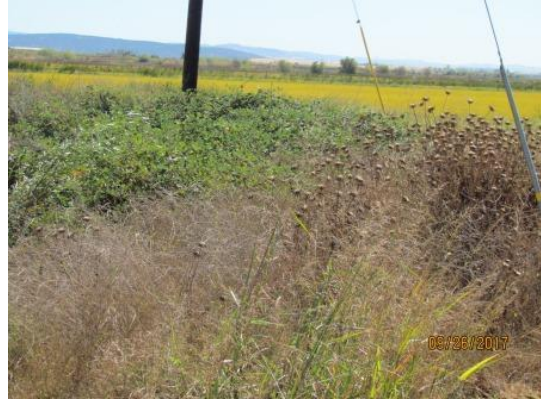
Photo 1 of 1 : FA_2018_NA0006_252_1_20180918_00001.jpg

LM Start	0.85	Rating **	U	Issue No.	1
LM End	0.96	Issue Type +	Ma	Location *	WS
Category	Earthen Levee			GPS Latitude/Longitude	
				Start	End
Item	Vegetation			39.294995 °	39.295021 °
				-121.557823 °	-121.555813 °
DWR ID	DWR_NA0006_01_f _ 2016_1				
Comment Code					
V2 : Remove the wild growth other than native grasses from the levee slopes.					
Inspector Comment					
Remove Blackberry bushes starting to take over waterside slope. Fall 2018.

View of Blackberry bushes that are starting to cover the waterside slope. Looking upstream waterside, Fall 2017.
